LINDSTRAND BALLOONS LTD

SERVICE BULLETIN NO. 4

ISSUE 2 - DATED 12.03.98

<u>Title:</u>	MULTI-BURNER GIMBAL BLOCK
<u>Classification:</u>	Recommended
<u>Applicability:</u>	Jetstream Double + CLF, Jetstream Triple, Jetstream Triple + CLF, Jetstream Quad Burners.
<u>Serial Numbers Affected:</u>	019, 018, 028, 041, 070, 066, W/O 1129/1130, 165, 082, 101, 090, 074, 094, 090, 100, 135, 095, 188, 171, 190, 197, w/o 1808, 200, 249, 250, 297, 298, 307, w/o 3312, 311 312, 325, 235, 326, 334, 336, 300, 335, 345, 350, 358, w/o 3711, 377, 372, 378, 387, w/o 3724, 391, 326, 304, 409, 412, 413, w/o 14314, 421,317, 427, 431, 439, 445, 446, 447.
<u>Compliance Standard:</u>	Inspection to be achieved within the next 10 hours flying time.
<u>Background:</u>	The gimbal block shown in Fig SB4-001 and used on all the above burner types is designed to allow variable friction, independently on each gimbal axes by adjustment of four socket head cap screws on each axes. In one installation, sufficient friction could not be achieved due to the two faces of the block meeting. Subsequent adjustment of the four cap screws or weakening of the central block section has caused thread failure within the central blo

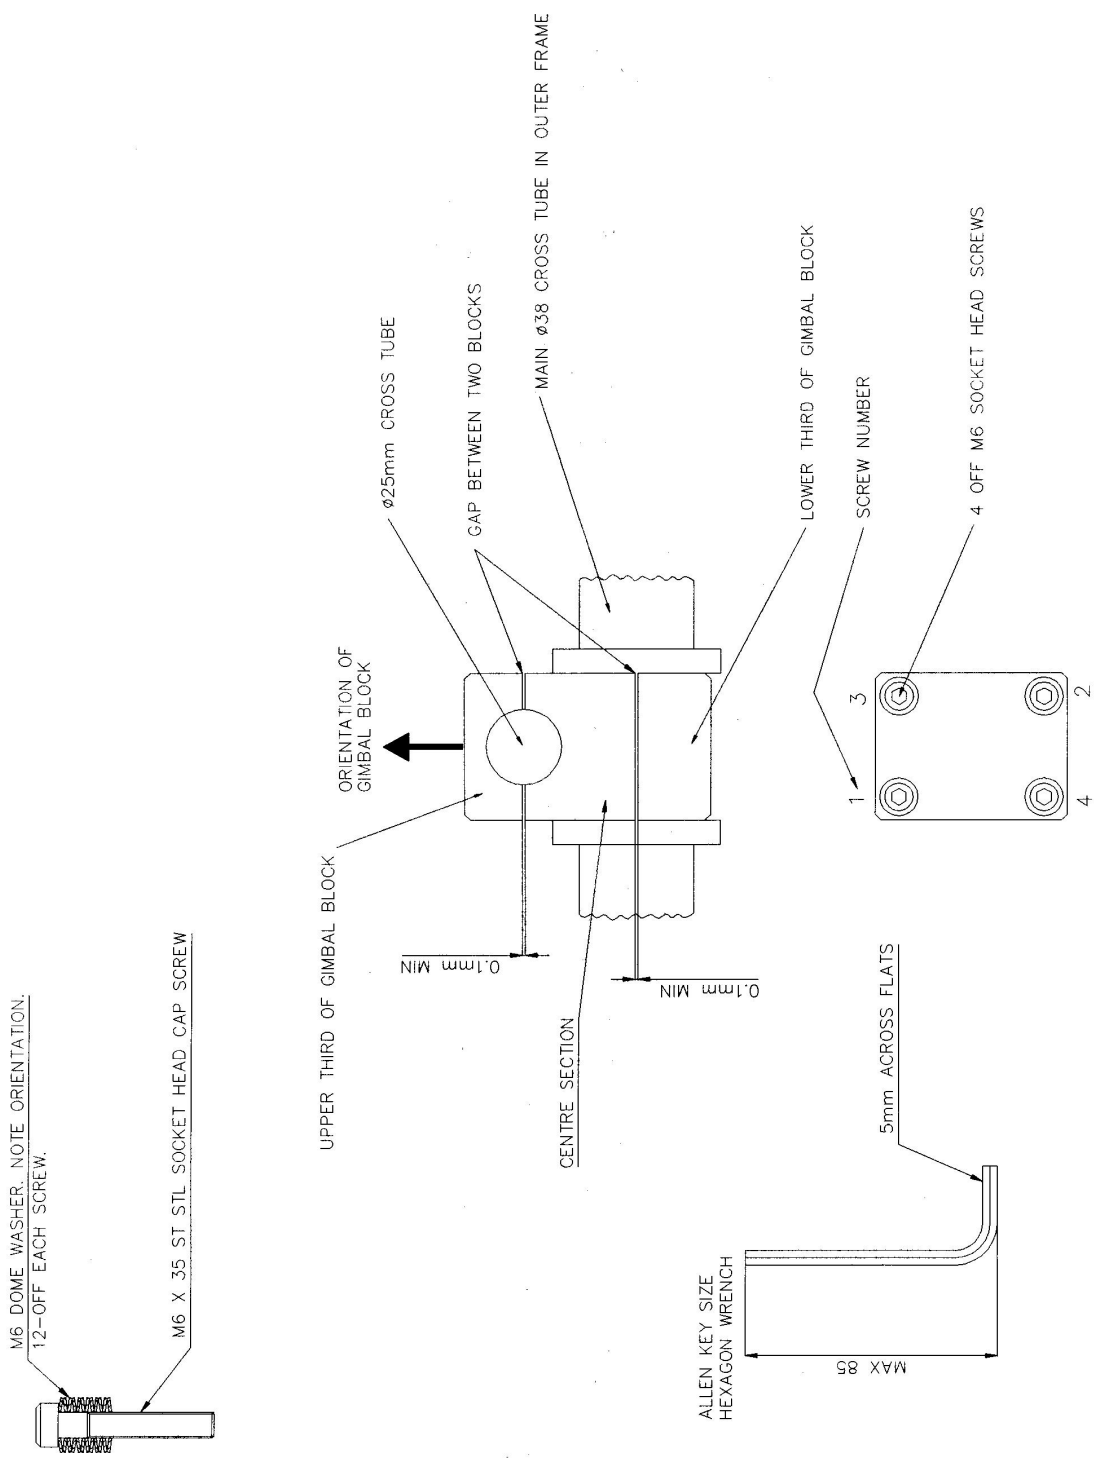
FIG SB4-002. ORIENTATION OF GIMBAL BLOCK

Both sides of the same gap should be equal and not less than those specified on Figure SB4-002. If the gaps are not equal, implement the procedure below.

If both sides of either gap are equal and less than those specified on Figure SB4-002, then a new gimbal assembly must be fitted. In this case, contact Lindstrand Balloons Ltd immediately.

Each side of the gap between the upper third of the gimbal block and the gimbal centre section should be equal and greater than the dimension specified on Figure SB4-002. Similarly, each side of the gap between the lower third of the gimbal block and the gimbal centre section should be equal and greater than the dimension specified on Figure SB4-002.

If after measurement, either of the gaps are less than those specified on Figure SB4-002, then a new gimbal assembly must be fitted. In this case, contact Lindstrand Balloons Ltd immediately.

If both sides of each gap are equal and greater than those specified on Figure SB4-002, then implement the following procedure:

1. Identify the screws securing the gimbal end cap to the centre section about the 25 mm cross tube.
2. Referring to Figure SB4-002:

Remove screw no. 1 using a 5 mm across flats Allen key (hexagon wrench), no bigger than that shown on the figure.

3. Apply Loctite 222 thread adhesive sparingly to the screw thread between 3 mm and 6 mm from the threaded end.
4. Ensure that the dome washers are assembled within the counter-bored hole of the gimbal block end cap, or over the screw, in the order shown on the figure.
5. Replace the screw in the hole and re-tighten using the allen key, until the screw is just nipped up.
6. Remove screw no. 2 using the allen key and repeat steps 3 through 5 inclusive.
7. Remove screw no. 3 using the allen key and repeat steps 3 through 5 inclusive.
8. Remove screw no. 4 using the allen key and repeat steps 3 through 5 inclusive.

9. Using the allen key, turn screw no. 1 a quarter turn. Repeat for screws no. 2, no. 3 and no. 4 in that order. Check the gimbal stiffness. Ensure that the screws are tightened in the above sequence and that both sides of the gap between the upper third of the gimbal and the gimbal centre section remain equal.

10. Repeat step 9 until the required gimbal stiffness is achieved.

11. Identify the screws securing the gimbal end cap to the centre section about the 38 mm cross tube. Repeat steps 2 through 8 inclusive.

For the Jetstream Double + CLF and Jetstream Triple burners, the gimbal block centre section is pinned to the 38 mm cross tube and thus no variation in friction is possible by adjustment of the gimbal screws. Fully tighten the screws in the order 1, 2, 3, 4 (see figure). For the Jetstream Triple + CLF and the Jetstream Quad burners, the gimbal friction is variable by adjustment of the gimbal screws. Repeat steps 9 through 10 inclusive, until the required gimbal stiffness is achieved.
