# LINDSTRAND BALLOONS LTD

## SERVICE BULLETIN No 6

### ISSUE 1 – DATED 24-8-99

- Title: BURNER VALVE REPAIR
- Classification: Recommended
- Applicability: **All** Jetstream Series 2 Double, Triple and Quad Burners identified by the following part numbers:

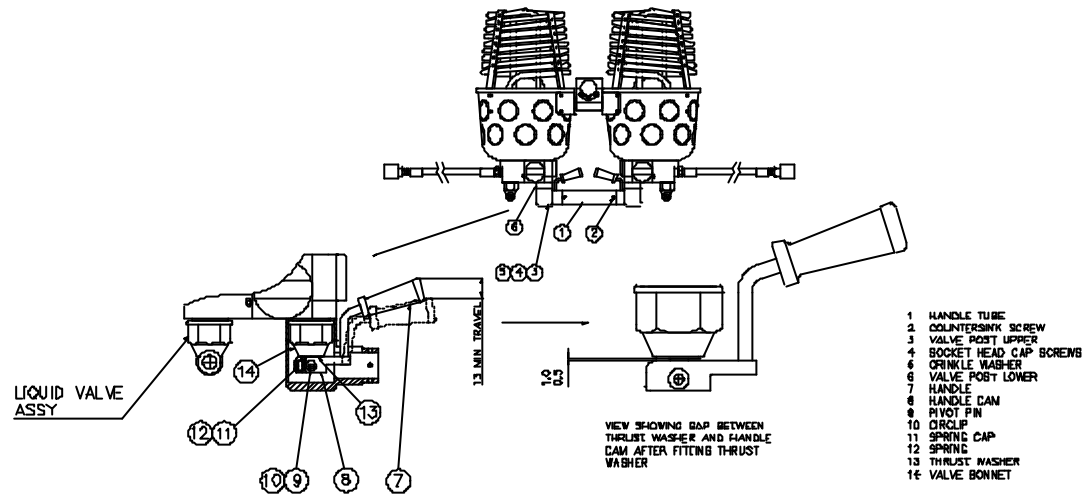
FIG 2. JETSTREAM SERIES 2 BURNER SQUEEZE ACTION MODE

- 3 If the valve handle travel is less than the minimum specified on figures 1 and 2, then the plastic thrust washer (items 4 and 13, figs 1 and 2 respectively) must be replaced as described in the Recovery Action section below.

- 10 Select the new thrust washer from the two supplied to give a clearance between the valve handle cam and the plastic thrust washer of between 0.5mm and 1mm (see figure 2). Note the thrust washer thicknesses as follows:

Thrust washer type BU-008-A-050-A	2.5mm thick
Thrust washer type BU-008-A-050-F	2.0mm thick
- 11 Align the holes in the handle cam with the hole in the valve spindle and replace the pivot pin.
- 12 Fit a new circlip to the pivot pin using a pair of external circlip pliers.
- 13 Using a set of feeler gauges, check that the clearance between the valve handle cam and the thrust washer is between 0.5mm and 1mm as shown on figure 2.
- 14 Place the lower and upper valve posts in position and fit the handle tube.

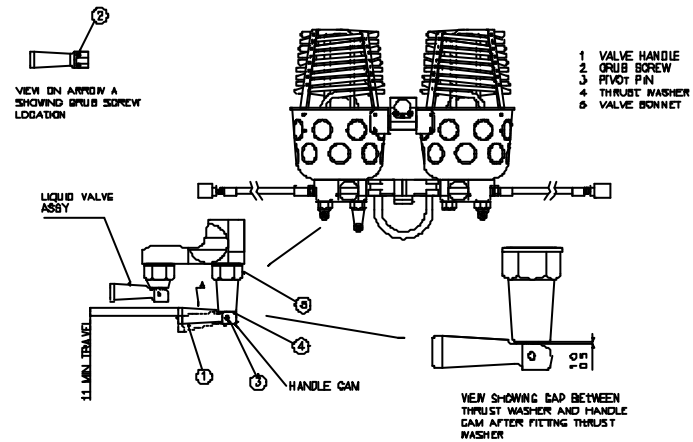
FIG 1. JETSTREAM SERIES 2 BURNER TOGGLE ACTION MODE

- 1 Disconnect the burner from any fuel supply and fully vent off any remaining fuel from within the burner.
- 2 Do not remove the valve from the valve block. Raise the valve handle and using a 2mm across flats allen key, undo the two grub screws located in the underside of the handle cam by a quarter turn.
- 3 Remove the pivot pin from the handle and withdraw the handle from the valve.
- 4 Using a knife blade if necessary, remove and discard the old plastic thrust washer from the recess in the valve bonnet.
- 5 Select the new thrust washer from the two supplied to give a clearance between the valve handle cam and the plastic thrust washer of between 0.5mm and 1mm (see figure 1). Note the thrust washer thicknesses as follows:

Thrust washer type BU-008-A-050-A	2.5mm thick
Thrust washer type BU-008-A-050-F	2.0mm thick
- 6 Align the pivot holes in the valve handle cam with the hole in the valve stem. Replace the pivot pin ensuring that the machined flat on the pin faces the two grub screws located in the handle cam.

- 7 Fully tighten the grub screws using a 2mm across flats allen key.
- 8 Using a set of feeler gauges, check that the clearance between the valve handle cam and the thrust washer is between 0.5mm and 1mm as shown on figure 1.
